Levee Settlement Problems and Improvements Study

Delta Water Supply Intake Pumping
Facility

Stockton, CA

August 4, 2016

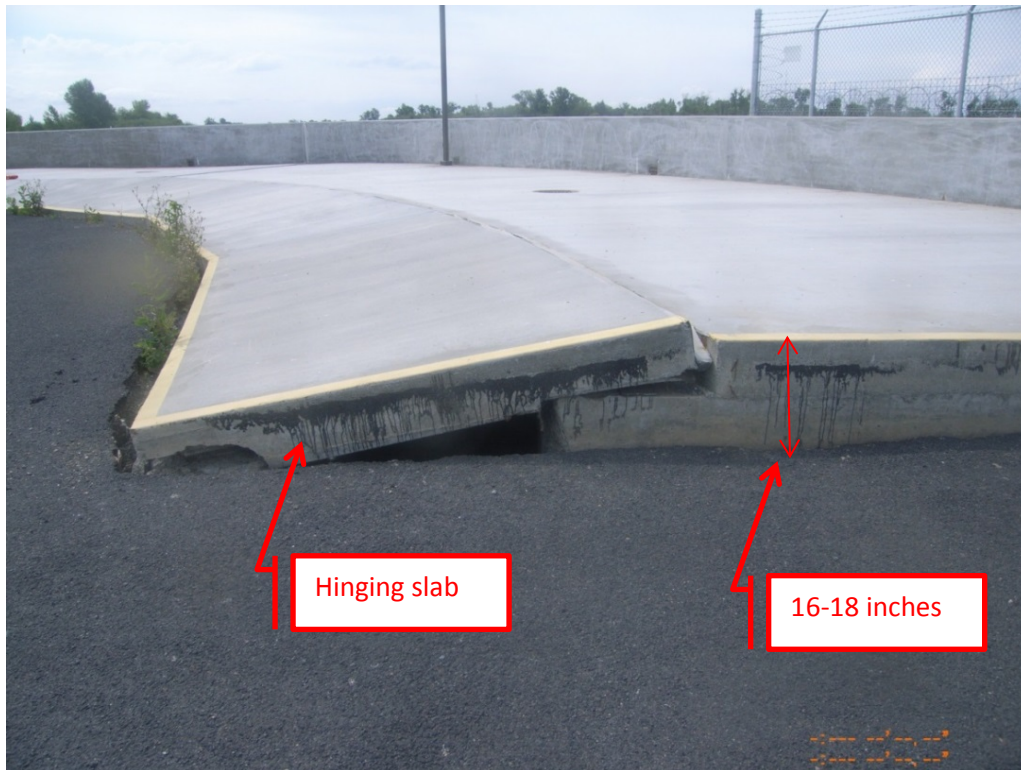
Figure 3. West driveway (measurement is representative of and not a complete survey)

The range of displacement measured at the boundary was approximately 16-18 inches on the west driveway and 12-14 inches on the east driveway.

Priority 2 was assigned to these problems, since repairs will improve safety and accessibility.

To address the discontinuity between the pile supported concrete driveway and the levee finish grade, ramps are recommended to provide a smooth transition. It is important that the ramps are designed to provide sufficient rating to allow vehicular and pedestrian traffic while not adding excessive weight on the levee in order to prevent an increase in settlement at installation locations. Ramps constructed of Geofoam (see description below) and covered with asphalt concrete (AC) could be installed to provide a smooth transition for vehicles and pedestrians access while providing the least amount of added weight.

To correct the disjoint of the concrete slabs along the sides of the driveways, the sloping slabs shall be removed and remaining void shall be filled using lightweight fill to restore the grade. A sheet pile should be installed between the levee ground and the road way foundation to protect the adjacent ground and retain the Geofoam. Additionally, a guard rail and an asphaltic concrete curb should be installed to prevent vehicles from driving on to the levee. Instead, vehicles will access the driveways using the ramps described above. Geofoam has been identified as a cost effective lightweight alternative to soil and heavy weight fills which can provide the structural integrity of the driveways. Geofoam is a cellular plastic material which provides strength with the low density, as required by the characteristics of this site, and is sealed to be unaffected by moisture. Although it must be covered with an additional lightweight fill or an aggregate layer, the use of Geofoam provides a low stress since it has a unit weight of 1 to 2 pounds per cubic foot (pcf) in comparison to typical engineered fill with a unit weight of 120 pcf. Additionally, this material is prefabricated in block forms of various standard sizes and easily positioned (Ref. 3). Geofoam is recommended for driveway repairs and to fill in any additional voids created due to settlement.

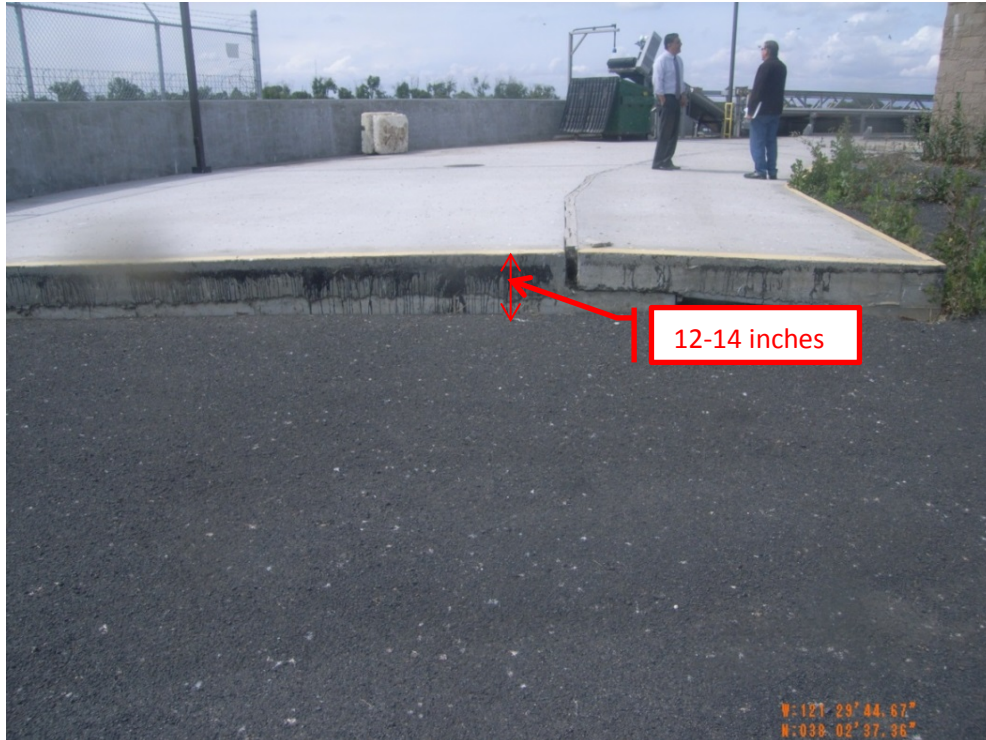
Figure 4. East driveway (measurement is representative and not a complete survey)

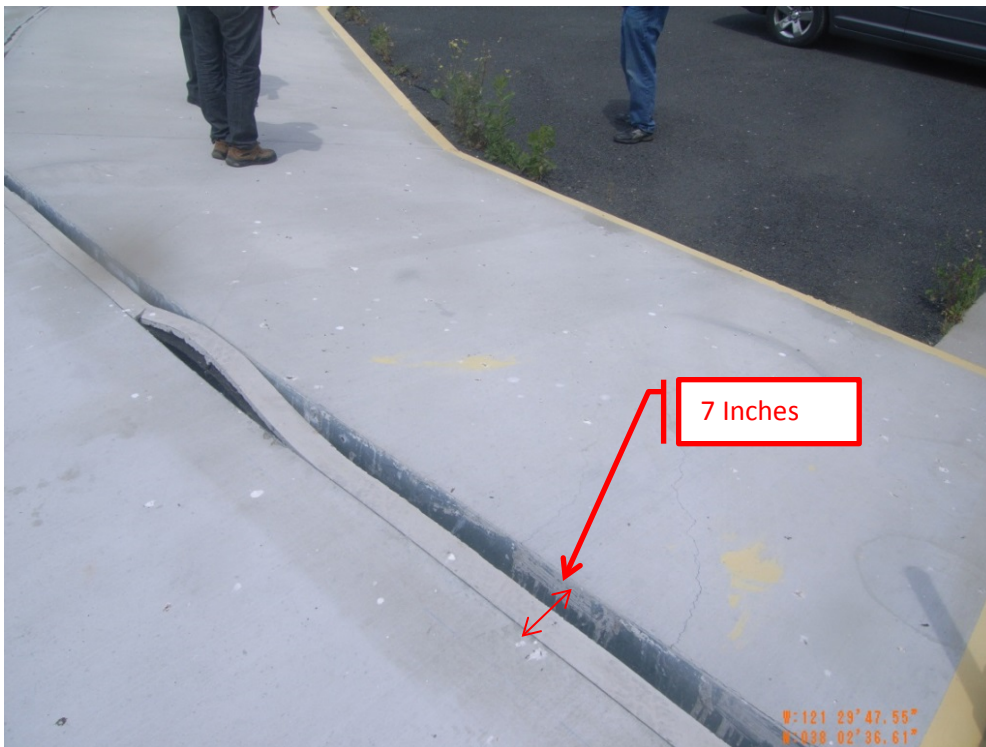
of the displacement no longer allows the driveways to be accessed by vehicles and is challenging for foot traffic. Additionally, each driveway is composed of two concrete slabs which have disjoined; the slab closer to pump station facility is hinging on the main wider slab and experiencing settlement at the non pile supported ends. Figure 3 through Figure 5 show the separation, exposure of the concrete driveway, displacement and gaps between the slabs that developed in the driveways.

Figure 5. Driveway concrete slab gap (measurement is representative and not a complete survey)

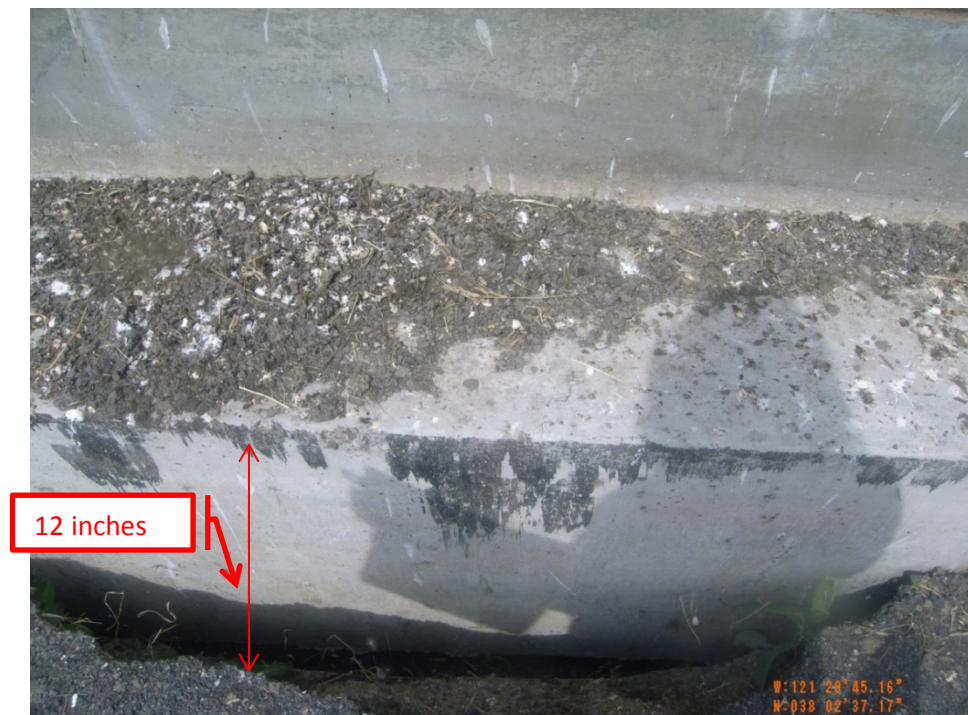
Priority 2 was assigned to these problems since they involve Code compliance and improvements to safety.

Figure 6. Gaps created between building foundation and surrounding surface (measurement is representative and not a complete survey)

For safety and structural integrity, it is recommended that the vertical door step differentials and horizontal voids created by levee settlement be corrected. For correction of large height differentials created from door threshold to door landing, lightweight fill and aluminum stoops and ramps could be installed. Installation of a ramp will facilitate the door entrance and provide safe access into the building along the levee to the building boundary. Height differentials exceeding 7 inches will require multiple risers (at max of 7 inches per riser) plus a handrail or a stoop and ramp. A stoop at the same elevation as the door threshold is required with both the step(s) and ramp options.

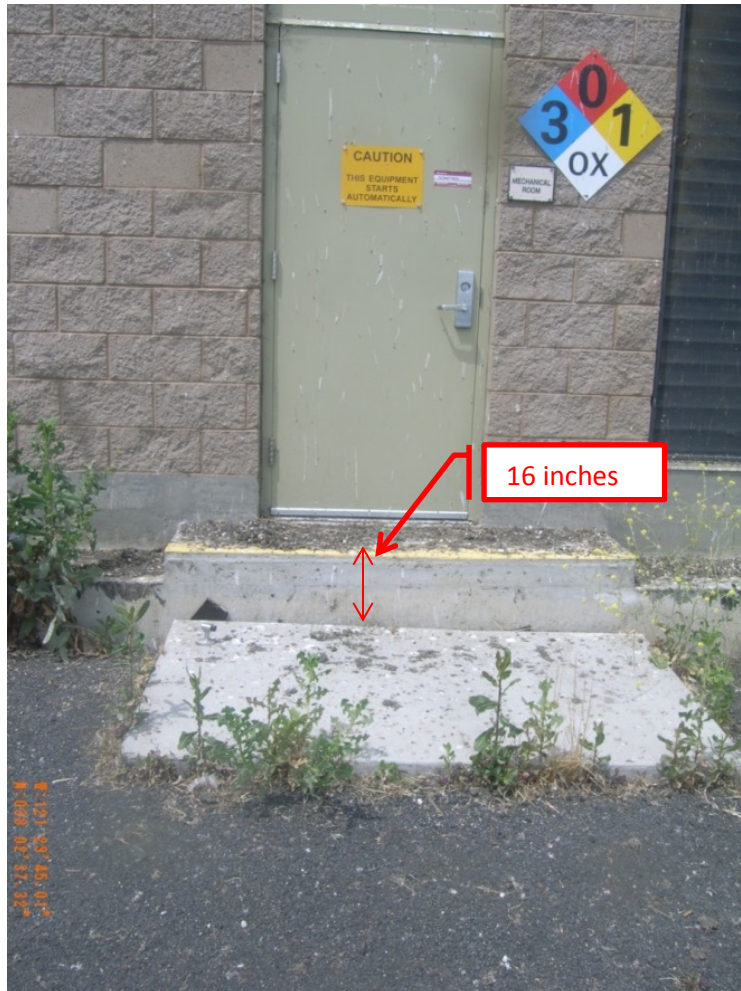
The pump station facility was built on pile supported foundation and consequently has experienced minimal settlement. Although the levee settlement has not affected the building's structural integrity, the exterior has settled and vertically disconnected in places from the building. Localized gaps between the building and the surrounding levee fill have been formed as seen in Figure 6. Additionally, the door stoop grade located along the levee (to south of the pump station building) has dropped lower than the surrounding ground resulting in a large grade differential. The California Building Code allows for a single step of 7 inches; the settlement in this location has exposed a greater step. The resulting drop presents more challenging conditions when there is a need to transport heavy equipment through the doors of the intake pump station facility; not to mention the difficulties to personnel using the doorway. Figure 7 shows the exposed step due to settlement.

Figure 7. Representative raised doorway step and separation from landing, east entrance door (measurement is representative and not a complete survey)

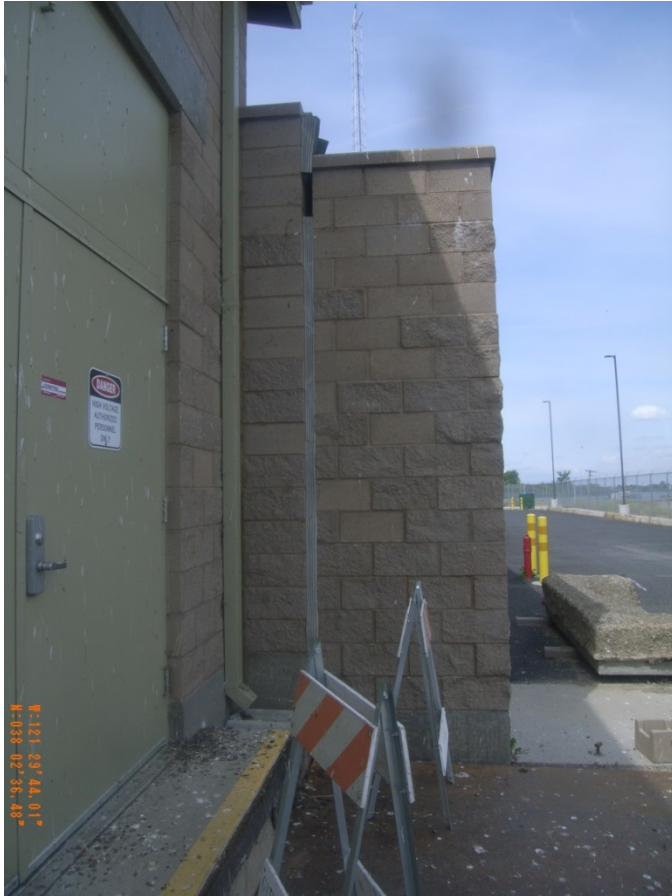
Mechanical and electrical systems and components in the interior of the yard have not presented concerns due to settlement. As shown in Figure 8 the surrounding concrete masonry unit (CMU) wall has settled uniformly, resulting in no visible signs of structural distress or instability. However, in one location the settlement has caused disconnection from the building and resulted in unsafe gaps in between the walls as shown in Figure 9.

Figure 8. CMU wall displacement located at the north (measurement is representative of the area and not a complete survey)

Yard improvements are required to maintain site safety. One major safety hazard in the yard is the separation of the CMU wall and the pile supported building along the south side of CMU wall. To repair the separation, a localized section of the wall could be removed and rebuilt. It is estimated that a 3 foot wide section of wall adjacent to the building be removed and rebuilt to cover the gap. The remaining section shall be left in place as it appears to be structurally stable and settling uniformly. The east CMU wall and building connection has not demonstrated significant separation and no modifications are recommended at this time.

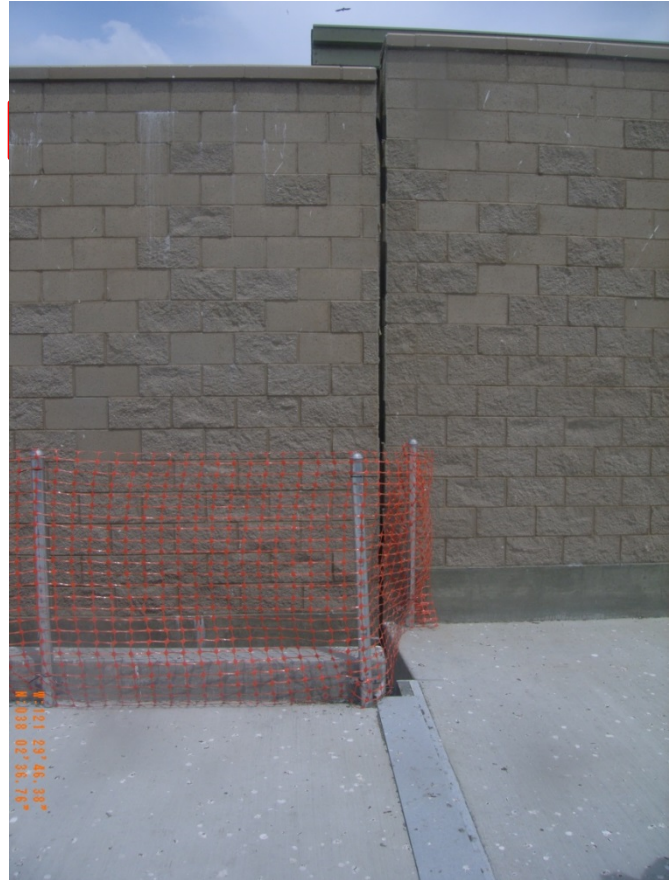
Figure 9. CMU wall displacement located at the south

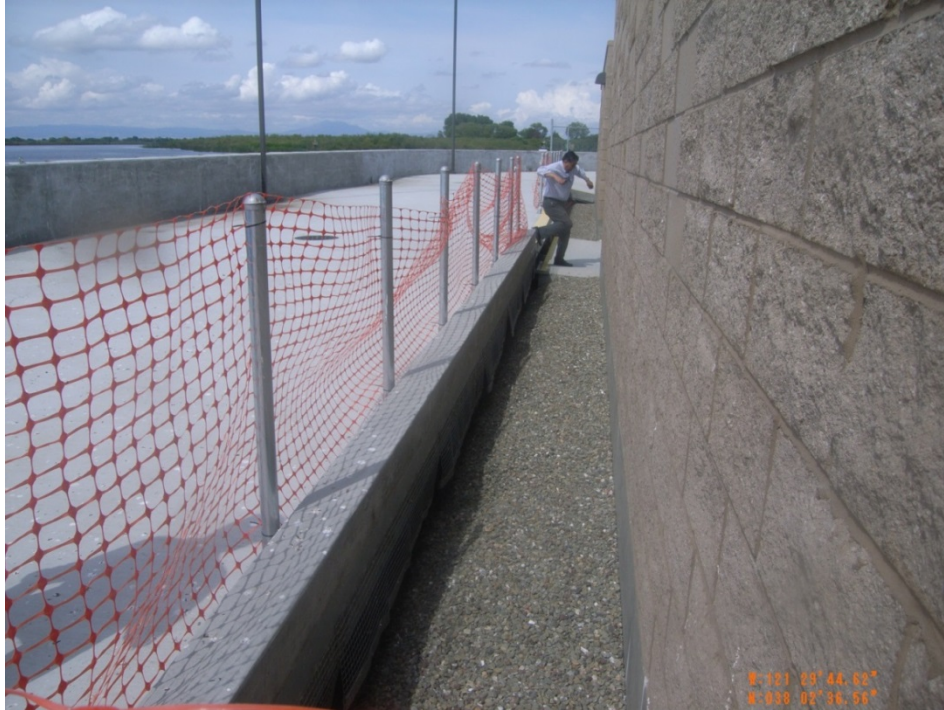
Large gaps have been observed in the south yard entrance where large voids developed due to the displacement of the yard and connection to the pile supported concrete driveway, as shown in Figure 10. Figure 11 presents a large unfilled void under the concrete slab driveway which is unsafe.

Due to safety considerations, Priority 2 was assigned to these problems.

Figure 10. Voids along south of building

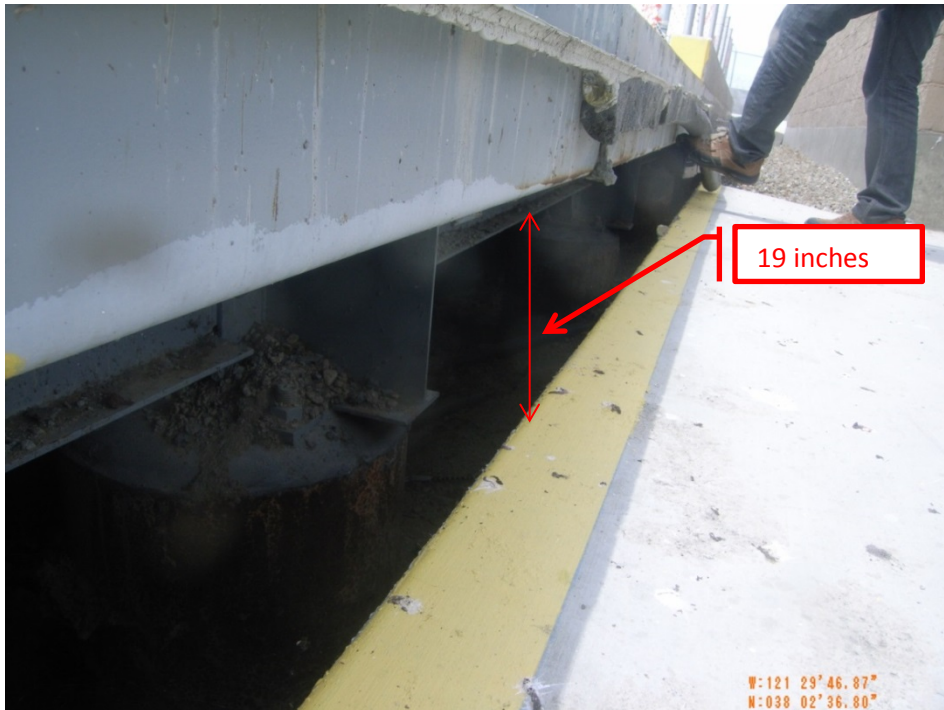
Figure 11. Representative voids along south of building (measurement is representative and not a complete survey)

The large vertical gaps that have been observed in the south yard entrance, shown in Figure 11, shall be covered to prevent any incidents. Lightweight aluminum plates are recommended to cover the voids. Additionally, a ramp could be added for a safe transition from the pile supported driveway to the yard south entrance to eliminate the large step down created by settlement.

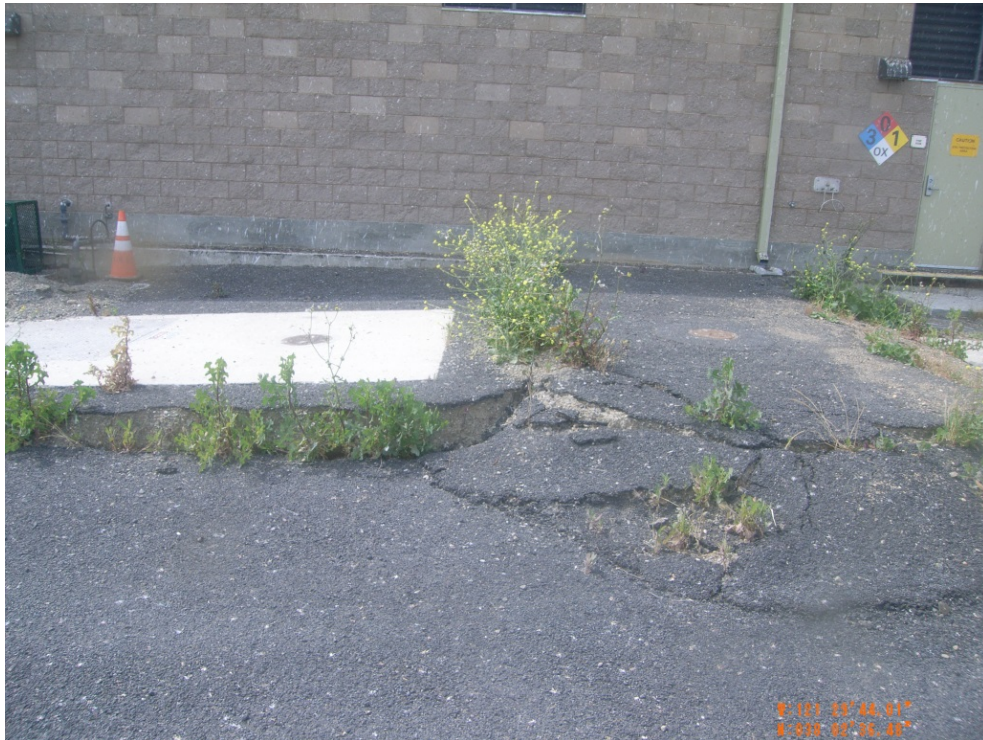
Although settlement has been mostly uniform across the entire site, in isolated locations irregular site settlement has resulted in cracking and grade deformations. The deformations have caused areas to protrude and resulted in some cracking of the pile supported concrete near the connection of the concrete and levee. Figure 13 shows uneven pavement along the north side of building caused by hinging on underlying pipe. Figure 12 and Figure 14 depict various locations of the effect of settlement to the site grading, which are considered non-functional issues.

Priority 5 was assigned to these problems as the issues are not critical to facility operations and investment in corrections to these deficiencies can be deferred.

Figure 12. Uneven pavement along north of building

To correct the site grading that has resulted from the differential settlement, Geofoam or other approved equal lightweight fill are recommended. The site surfaces in particular areas could be re-graded to regain the smooth transition throughout the site keeping the site slope required for proper storm drainage. Spot locations can be filled with the chosen lightweight fill; fill locations can only be placed outside of the levee prism to maintain the levee integrity. To prevent additional weight on the site, a minimum amount of lightweight fill and removal of existing grade is recommended. Any cracks developed shall be filled or sealed using selected lightweight fill or sealant that will provide cohesiveness and weather protection to cracks.

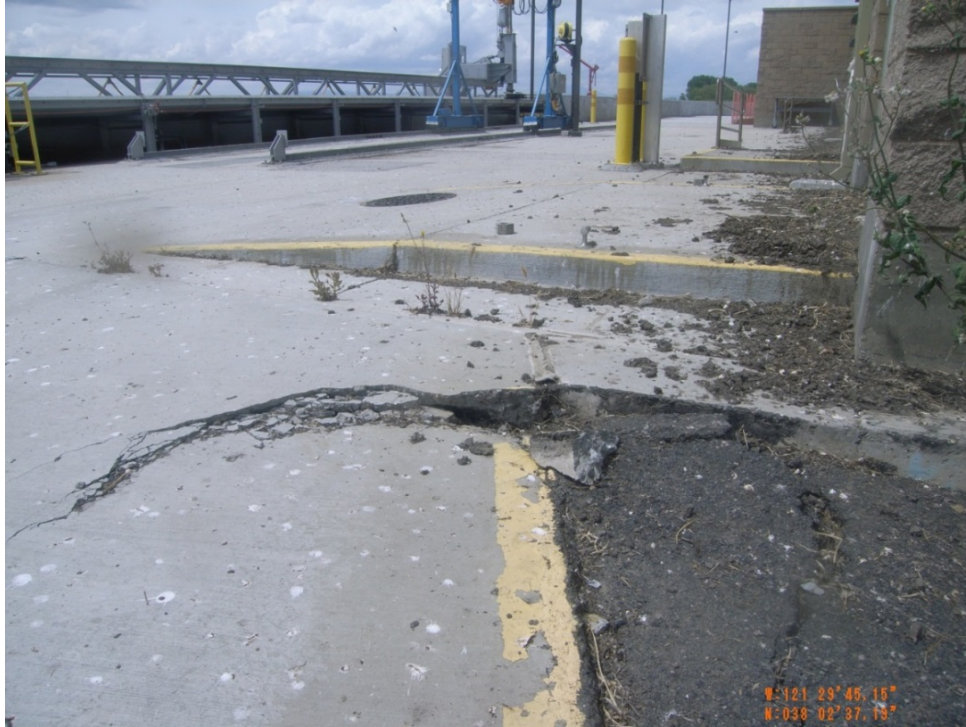
Figure 13. Crack created in concrete due to displacement, south of building

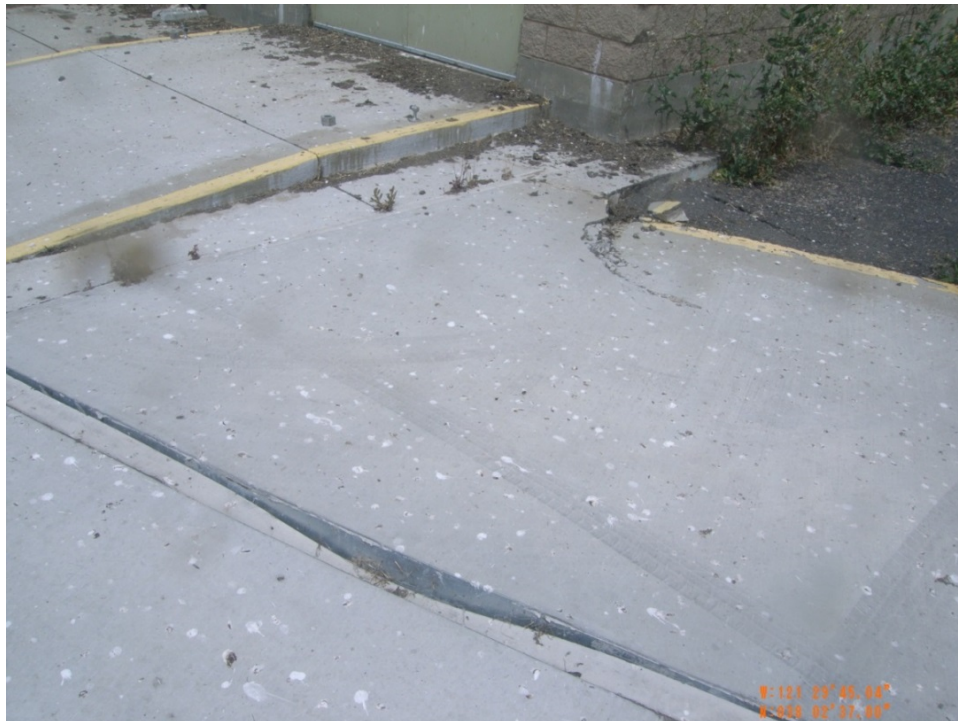
Figure 14. Disconnections in the concrete, south of building

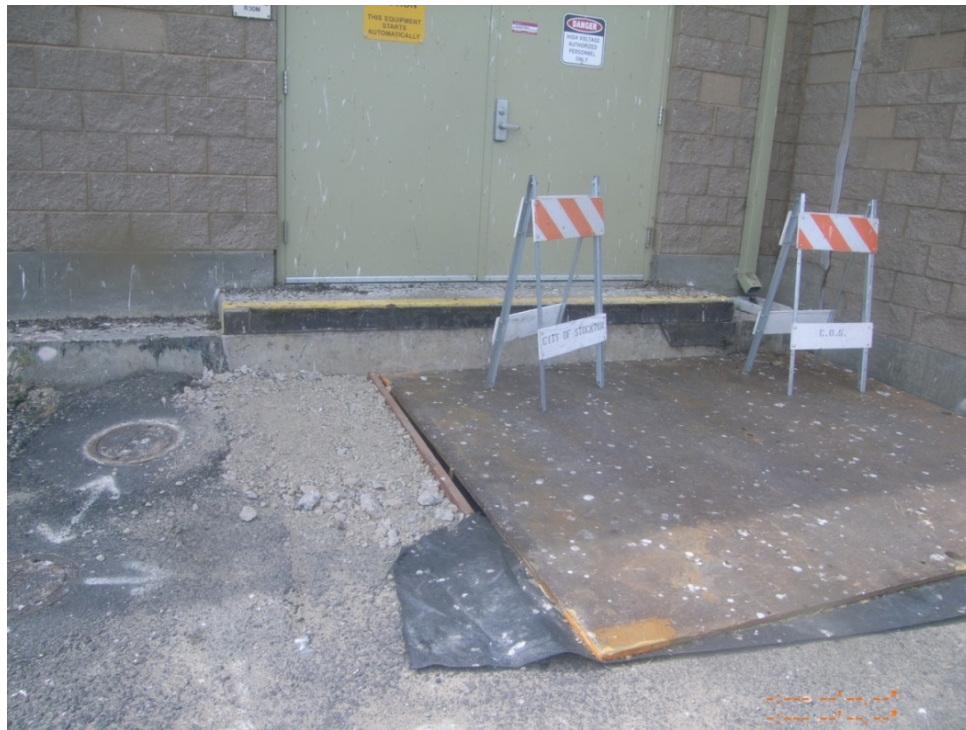
Overall the site electrical systems are still functional. During the site visit on May 14, 2015 it was reported that various corrections to the conduits entering/exiting the building have previously been performed by City staff. These corrections included providing additional slack to the lines and introducing flexible transitions for the conduits. Maintenance staff reported that a concrete slab landing located at the north end of the building had to be removed to allow conduit slack to be extended. Additional corrections were made in the interior of the yard to allow for conduits to be damage-free and continuously routed.

Priority 1 and 4 was assigned to these problems due to the sensitivity with electrical functionality of the facility.

Figure 15. Location of where the building landing was removed to allow for conduit slack to be extended at north side of building

During the site visit performed on May 14, 2015, buried conduits were not inspected. It is recommended that conduits that may be jeopardized by site settlement be corrected to assure site functionality. Based on site plans, approximately 10 conduits are crossing through the pile supported

area and the settling levee and are at risk due to the differential elevation caused by settlement. At locations where the buried conductors have been affected by the settlement, conduit expansion and deflection couplings should be installed. Once couplings have been installed all exposed conduits shall be covered for safety. Alternative improvements may include lightweight flexible backfill around new buried couplings to minimize restriction for movement of the pipe due to further settlement. Conduit expansion and deflection couplings manufactured by Course Hinds have been identified as a candidate to provide the flexibility required for settlement and a water-tight connection. The deflection couplings protect conduit wiring system from damage that may result from axial expansion and contraction up to $\frac{3}{4}$ inch and angular or parallel misalignment (Ref. 1), as shown in Figure 21.

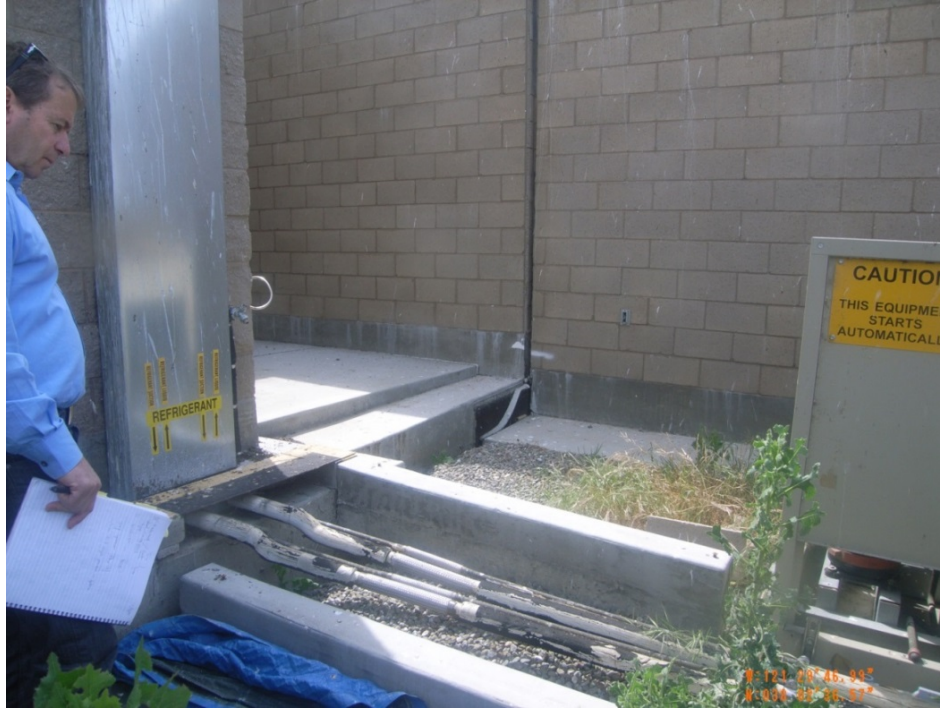
Figure 16. Yard construction repairs - covering plate was removed to allow conduit realignment, various bends were added to the conduit to adjust conduits at the settling ground and pile supported facility; conduits have been left exposed in case of future construction

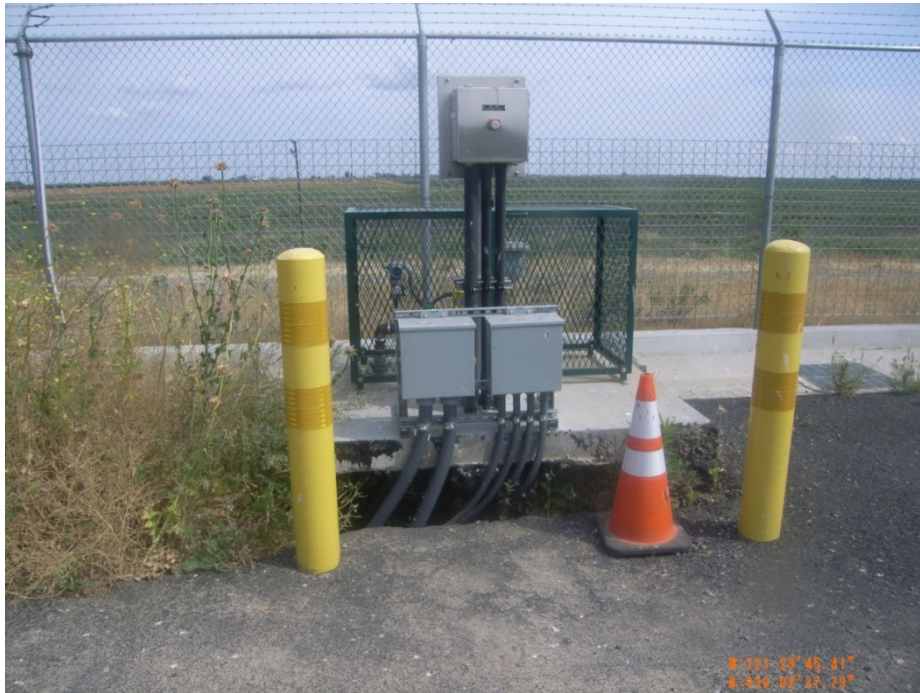
The groundwater well located on site is used to supply water for pump station operation. The well is located on the north side of building surrounded by the settling ground. The well and casing are not settling as the depth of the casing bottom extends deeper than the peat soil layer. Settlement of the surrounding ground has resulted in exposure of the well concrete pad as shown in Figure 17 and Figure 18; the pad will need to be replaced. During the site visit, the well was reported to not be operating due to a burnt-out motor, settlement was not the cause. The pump was replaced in the spring of 2016 and is currently working appropriately. Priority 1 was assigned to these problems since reliance on well water is important to the operation of the facility.

Figure 17. Site well, north of building

The well located on the north side of building is critical for pump station operation since it supplies water for pump station cooling and other uses. No current issues have been reported; the pump was repaired in the spring of 2016 and is currently working appropriately. To provide stabilization for the well piping and electrical components the existing concrete pad should be removed and replaced with a lightweight concrete pad adjacent to, but not attached to, the well casing. The remaining void beneath the new lower slab should be filled with approved lightweight fill. The existing piping and electrical components shall be supported with adjustable supports. If necessary, the electrical connections to the well shall be corrected and conduits be replaced with expansion and deflection couplings to prevent future electrical damage. Additional damage to the well that may result from the settlement in the levee shall be corrected accordingly.

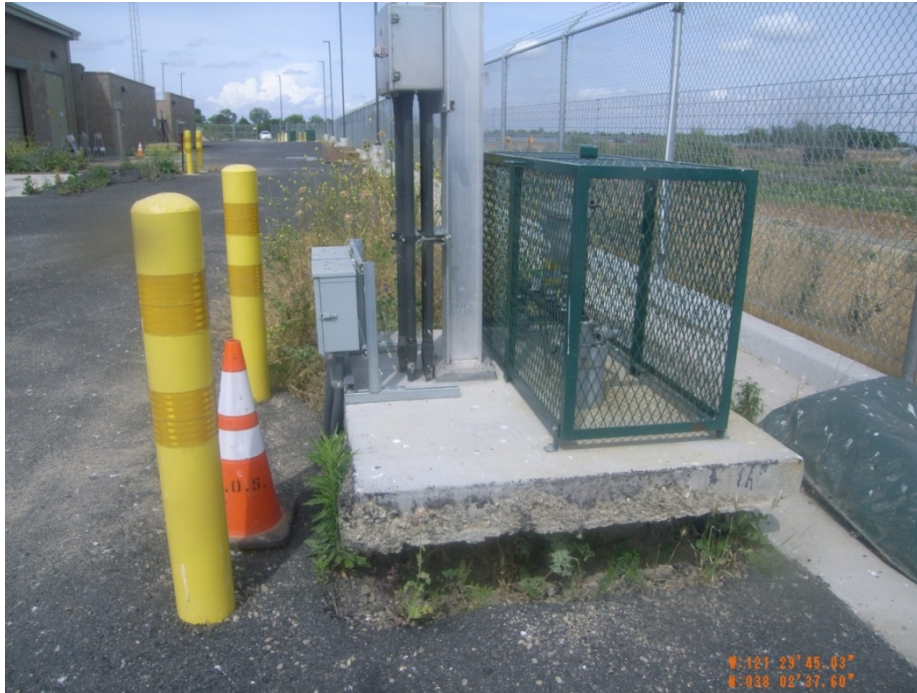
Figure 18. Site Well, north of building

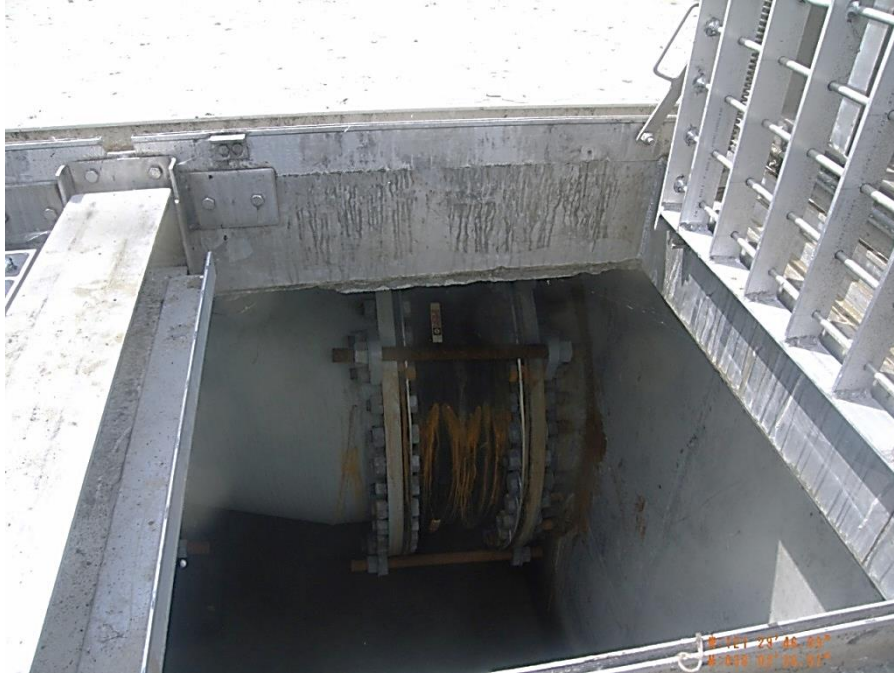
Two major pipe connections are located within the levee. The pipelines are 54-inch and 16-inch pipes with connections in vaults. The original 54-inch pipe flexible joint was replaced in 2013 with an offset flexible joint to allow for additional displacement to the connection due to settlement. Per the site visit in May 2015, no visible damage is affecting the joint as shown in Figure 19. A new 54-inch offset flexible joint is in the process of being installed to allow for additional settlement. The 16-inch pipe connection did not exhibit any visible damage from the settlement as shown in Figure 20. However, a replacement joint for the 16-inch pipeline should be provided to allow for possible future settlement. Additional 54-inch and 16-inch joint replacements may be needed in the future. Priority 1 was assigned to this issue because they directly involve functionality of the facility.

The maximum allowable differential settlement on the 54-inch pipeline is 8.9 inches/100-feet and for the 16-inch pipeline is 28.6 inches/100-feet as reported in the *Raw Water Pipeline Differential Settlement – Respond to RD 2029 Question Memo* dated March 20, 2013 (Ref. 7). Measurements taken along both pipelines indicate that the actual differential settlement is very small. No action is required for this issue.

Figure 19. 54-inch double expansion joint pipe connection

To maintain site functionality, the pipelines and pipe connections must remain suitable for proper flow. As mentioned in the Pipeline section, two major pipeline components that are of concern are the 54-inch and 16-inch raw water pipelines that extend through the levee and have connections to the pile supported components. Ongoing monitoring of the levee elevation indicates that there is negligible differential settlement along the pipelines within the levee and they are not currently in danger of failure. To accommodate the settlement of the pipeline near the pile supported structure, double heavy duty reinforced rubber expansion joints were installed in vaults. The joint for the 54-inch pipeline is in the process of being replaced with an offset joint completed by Holtz Rubber located in Lodi, California to essentially “reset” the joint for future settlement. While the settlement rate has decreased, there is uncertainty of when settlement will completely stop; therefore, it is recommended that site pipelines remain under periodic inspection. In the event that the recently installed flexible joint on the 54-inch pipeline reaches its maximum allowable deflection, a new offset flexible joint should be measured and installed. The 16-inch pipeline joint is still within its deflection limits, but it should also be replaced with a new offset flexible joint to allow for deflection due to future settlement.

A Flex-Tend flexible expansion joint by EBAA Iron Inc. has also been identified as a long term replacement for the expansion joint connecting the pipelines. The Flex-Tend expansion double ball joint, as shown in Figure 23, would be required for the deflections at this site. Installing a Flex-Tend expansion joint will require existing design modifications including a larger vault. While this type of joint is normally fabricated in sizes up to 48-inch diameter a 54-inch double ball joints can be fabricated as a special order. The lay length of the 48-inch double ball joint is 13.25 feet. Assuming the 54-inch joint is

the same length, this would require that the existing 13.5 feet wide by 9.5 feet long vault be replaced with a 13.5 feet wide by 17 feet long vault with a new piping connection. The estimated cost for long term replacements is included in Appendix D.

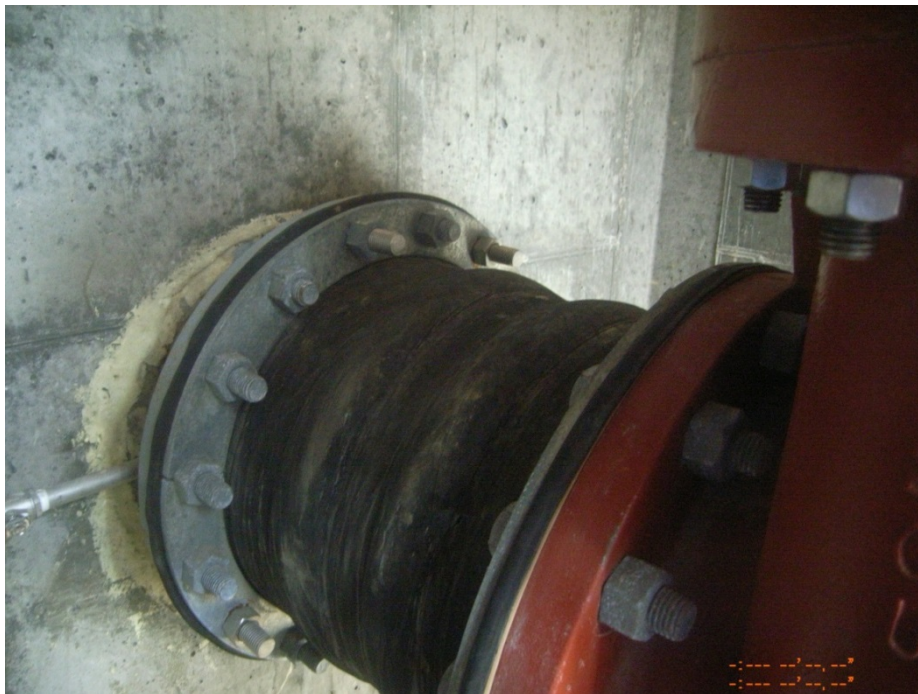
Figure 20. 16-inch pipe connection
