Levee Settlement Problems and Improvements Study

Delta Water Supply Intake Pumping
Facility

Stockton, CA

August 4, 2016

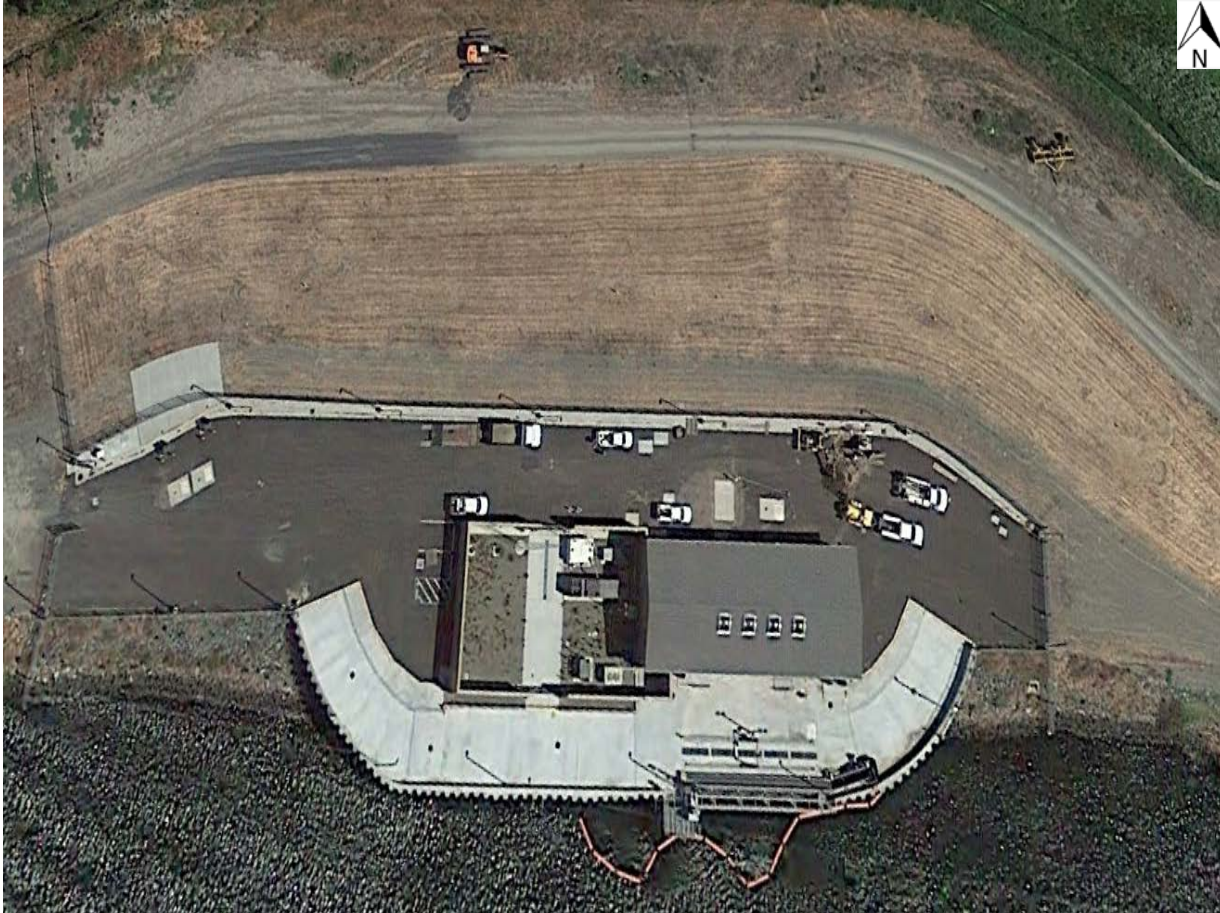
Figure 2. Site Aerial

The site includes two pile supported concrete driveways located east and west of the pump station building. These driveway sections were intended to provide for smooth transition to the section of the levee that has a chip seal overlay to allow vehicular travel as shown in Figure 2. Both driveways connecting the pile supported concrete area to the levee currently have stepped disconnections at the boundary and grade separation due to the surrounding settlement. The settlement has exposed the concrete and created a grade discontinuity between the levee and the concrete driveway. The severity

of the displacement no longer allows the driveways to be accessed by vehicles and is challenging for foot traffic. Additionally, each driveway is composed of two concrete slabs which have disjoined; the slab closer to pump station facility is hinging on the main wider slab and experiencing settlement at the non pile supported ends. Figure 3 through Figure 5 show the separation, exposure of the concrete driveway, displacement and gaps between the slabs that developed in the driveways.

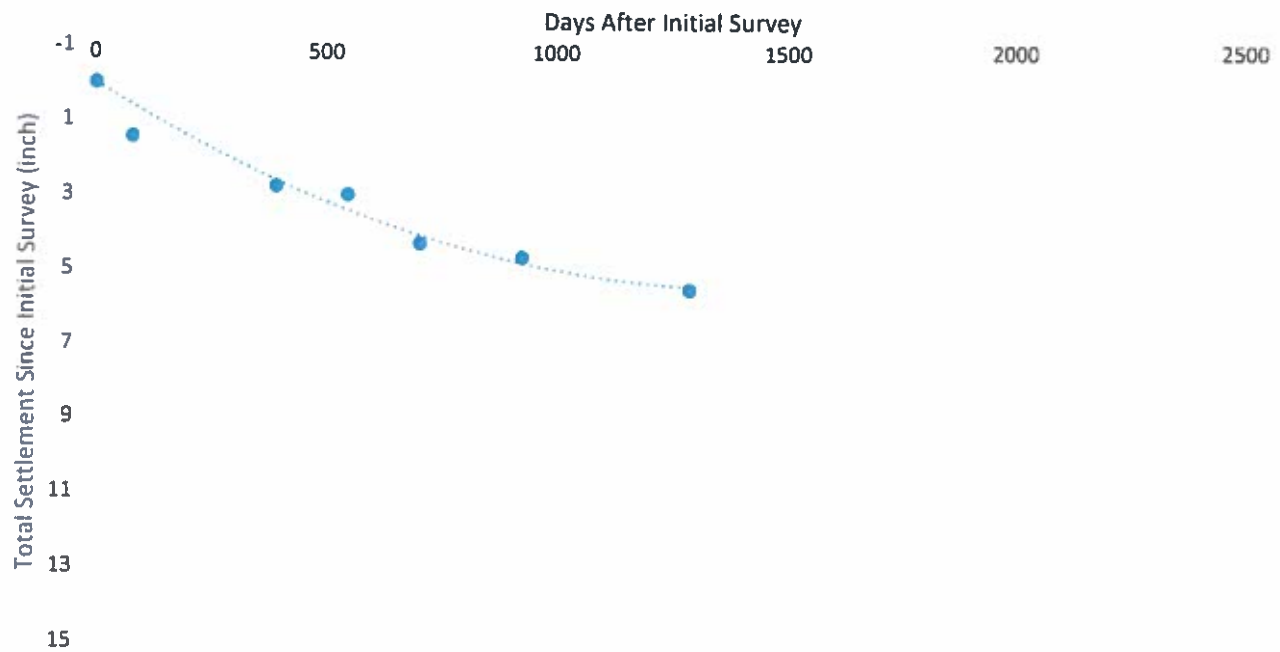
430-2INPIPE					
Survey Date	Measured Elevations (feet)	Incremental Settlement Since Previous Survey (inch)	Total Settlement Since Initial Survey (inch)	Days After Previous Survey	Days After Initial Survey
7/2/2012	-4.23	0	0	0	0
9/19/2012	-4.35	1.44	1.44	79	79
7/29/2013	-4.46	1.32	2.76	313	392
12/29/2013	-4.4797	0.2364	2.9964	153	545
6/4/2014	-4.5885	1.3056	4.302	157	702
1/14/2015	-4.619	0.366	4.668	224	926
4/1/2016	-4.69	0.852	5.52	443	1290

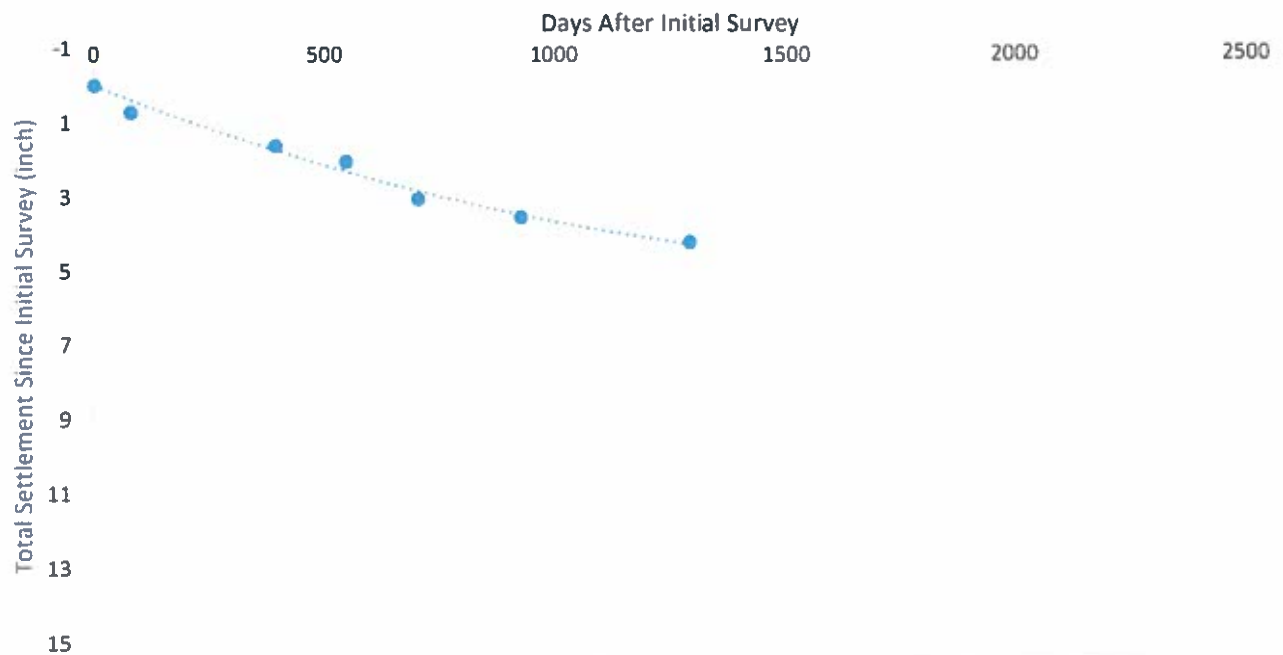
429-2INPIPE					
Survey Date	Measured Elevations (feet)	Incremental Settlement Since Previous Survey (inch)	Total Settlement Since Initial Survey (inch)	Days After Previous Survey	Days After Initial Survey
7/2/2012	-5.95	0	0	0	0
9/19/2012	-6.01	0.72	0.72	79	79
7/29/2013	-6.084	0.888	1.608	313	392
12/29/2013	-6.119	0.42	2.028	153	545
6/4/2014	-6.2029	1.0068	3.0348	157	702
1/14/2015	-6.244	0.4932	3.528	224	926
4/1/2016	-6.3	0.672	4.2	443	1290

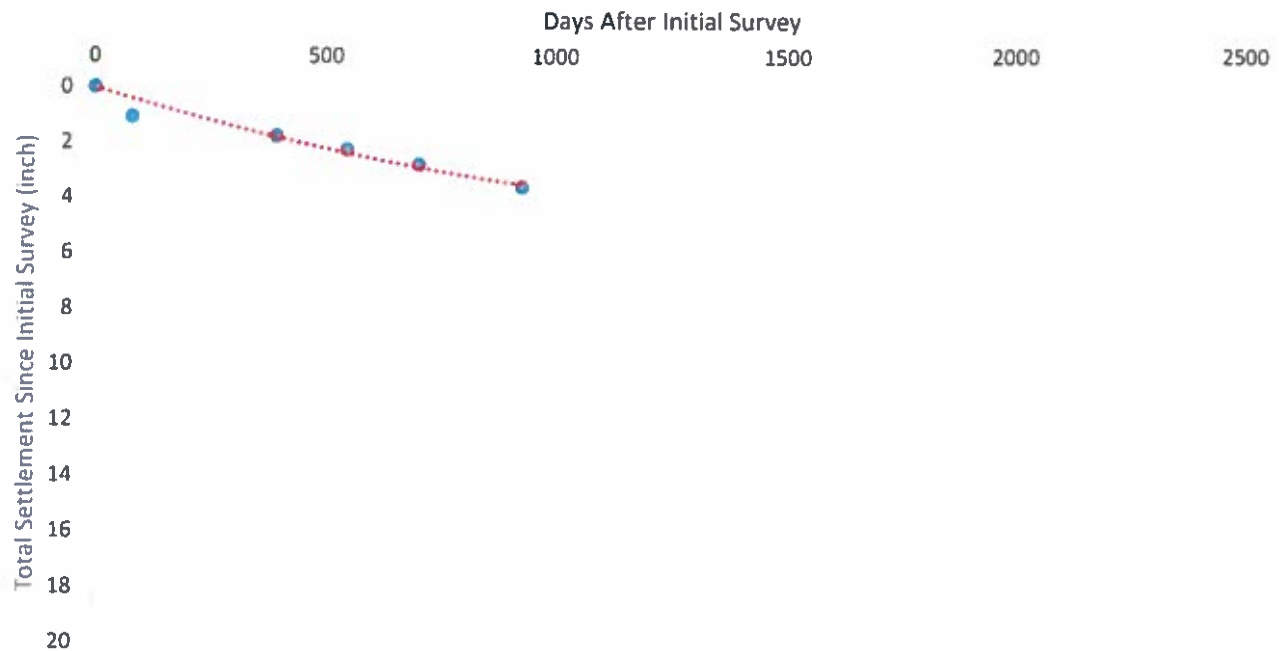
428-PIPERANOVER					
Survey Date	Measured Elevations (feet)	Incremental Settlement Since Previous Survey (inch)	Total Settlement Since Initial Survey (inch)	Days After Previous Survey	Days After Initial Survey
7/2/2012	-6.21	0	0	0	0
9/19/2012	-6.3	1.08	1.08	79	79
7/29/2013	-6.355	0.66	1.74	313	392
12/29/2013	-6.3963	0.4956	2.2356	153	545
6/4/2014	-6.4419	0.5472	2.7828	157	702
1/14/2015	-7.175	0.7972	3.58	224	926
4/1/2016	-7.175	0.7972	4.3772	443	1290

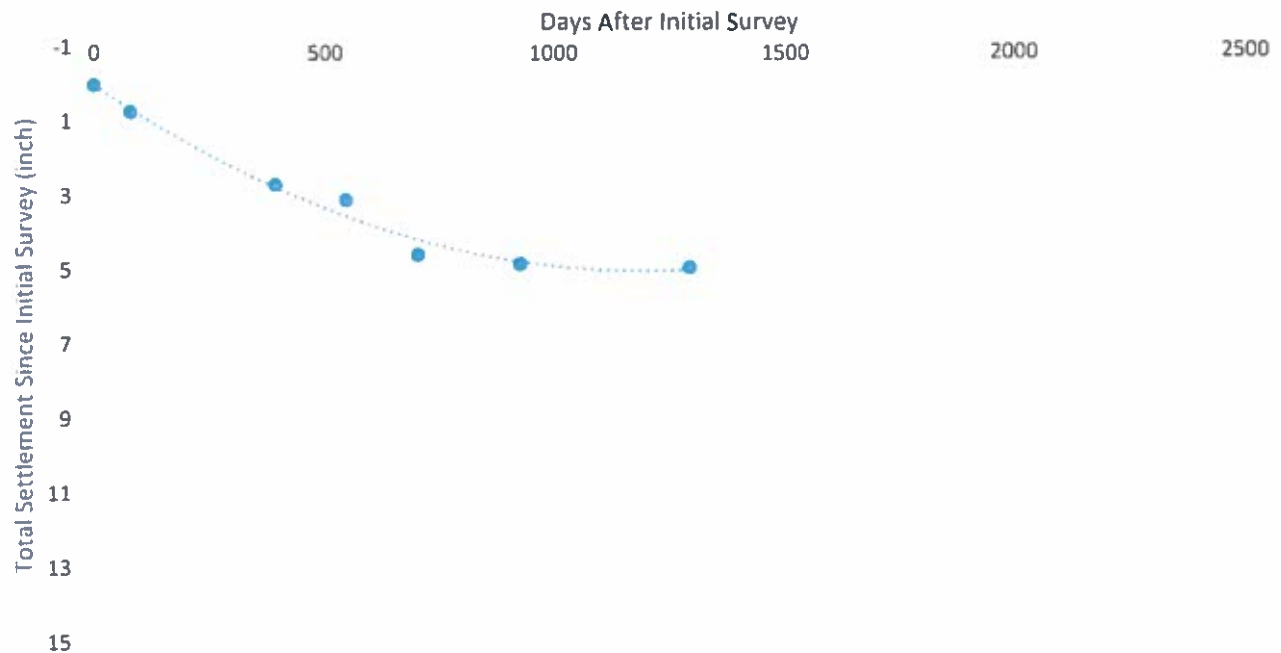
427-2INPIPE					
Survey Date	Measured Elevations (feet)	Incremental Settlement Since Previous Survey (inch)	Total Settlement Since Initial Survey (inch)	Days After Previous Survey	Days After Initial Survey
7/2/2012	-0.97	0	0	0	0
9/19/2012	-1.03	0.72	0.72	79	79
7/29/2013	-1.194	1.968	2.688	313	392
12/29/2013	-1.2284	0.4128	3.1008	153	545
6/4/2014	-1.351	1.4712	4.572	157	702
1/14/2015	-1.372	0.252	4.824	224	926
4/1/2016	-1.38	0.096	4.92	443	1290

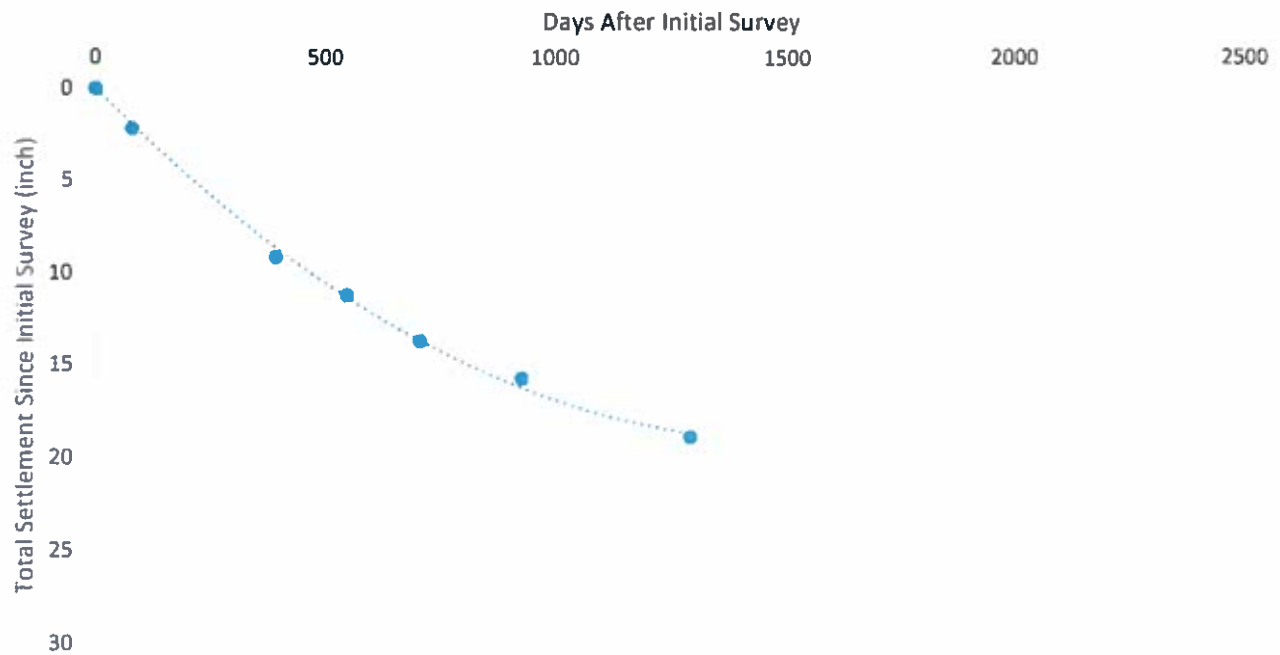
408-CP36					
Survey Date	Measured Elevations (feet)	Incremental Settlement Since Previous Survey (inch)	Total Settlement Since Initial Survey (inch)	Days After Previous Survey	Days After Initial Survey
7/2/2012	12.72	0	0	0	0
9/19/2012	12.54	2.16	2.16	79	79
7/29/2013	11.959	6.972	9.132	313	392
12/29/2013	11.789	2.04	11.172	153	545
6/4/2014	11.5815	2.49	13.662	157	702
1/14/2015	11.412	2.034	15.696	224	926
4/1/2016	11.15	3.144	18.84	443	1290

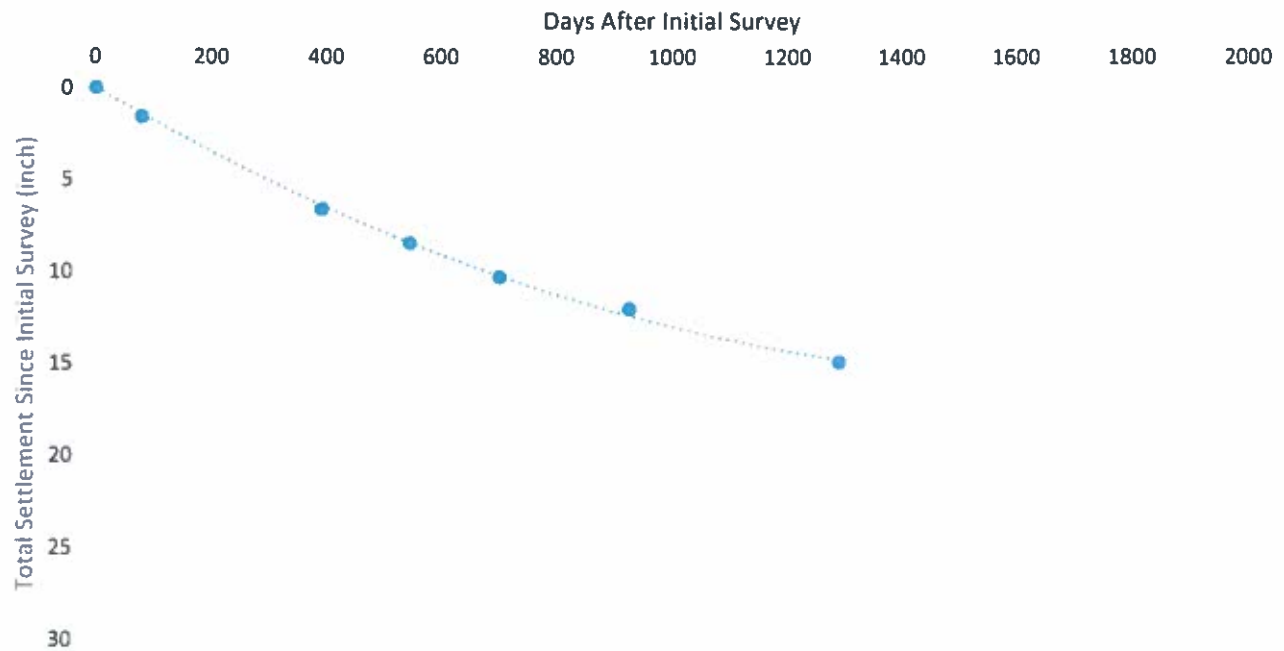
407-CP35					
Survey Date	Measured Elevations (feet)	Incremental Settlement Since Previous Survey (inch)	Total Settlement Since Initial Survey (inch)	Days After Previous Survey	Days After Initial Survey
7/2/2012	12.86	0	0	0	0
9/19/2012	12.73	1.56	1.56	79	79
7/29/2013	12.313	5.004	6.564	313	392
12/29/2013	12.1579	1.8612	8.4252	153	545
6/4/2014	12.004	1.8468	10.272	157	702
1/14/2015	11.861	1.716	11.988	224	926
4/1/2016	11.62	2.892	14.88	443	1290

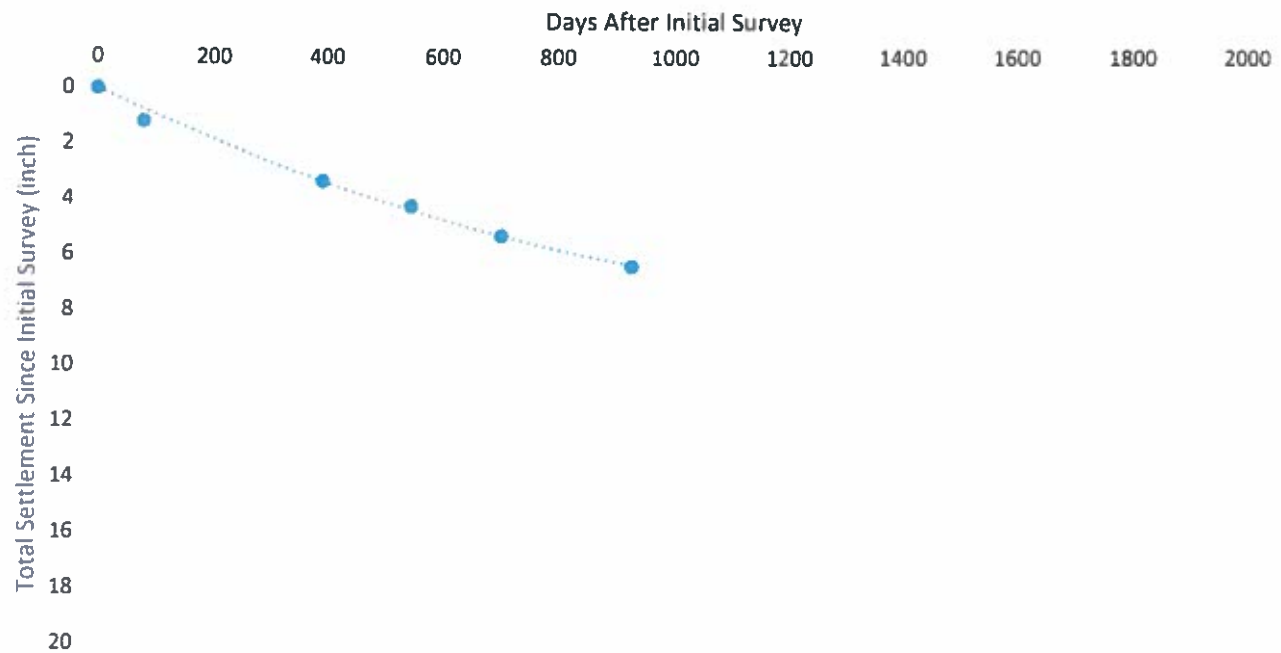
405-TF					
Survey Date	Measured Elevations (feet)	Incremental Settlement Since Previous Survey (inch)	Total Settlement Since Initial Survey (inch)	Days After Previous Survey	Days After Initial Survey
7/2/2012	8.3	0	0	0	0
9/19/2012	8.2	1.2	1.2	79	79
7/29/2013	8.019	2.172	3.372	313	392
12/29/2013	7.9439	0.9012	4.2732	153	545
6/4/2014	7.8555	1.0608	5.334	157	702
1/14/2015	7.764	1.098	6.432	224	926

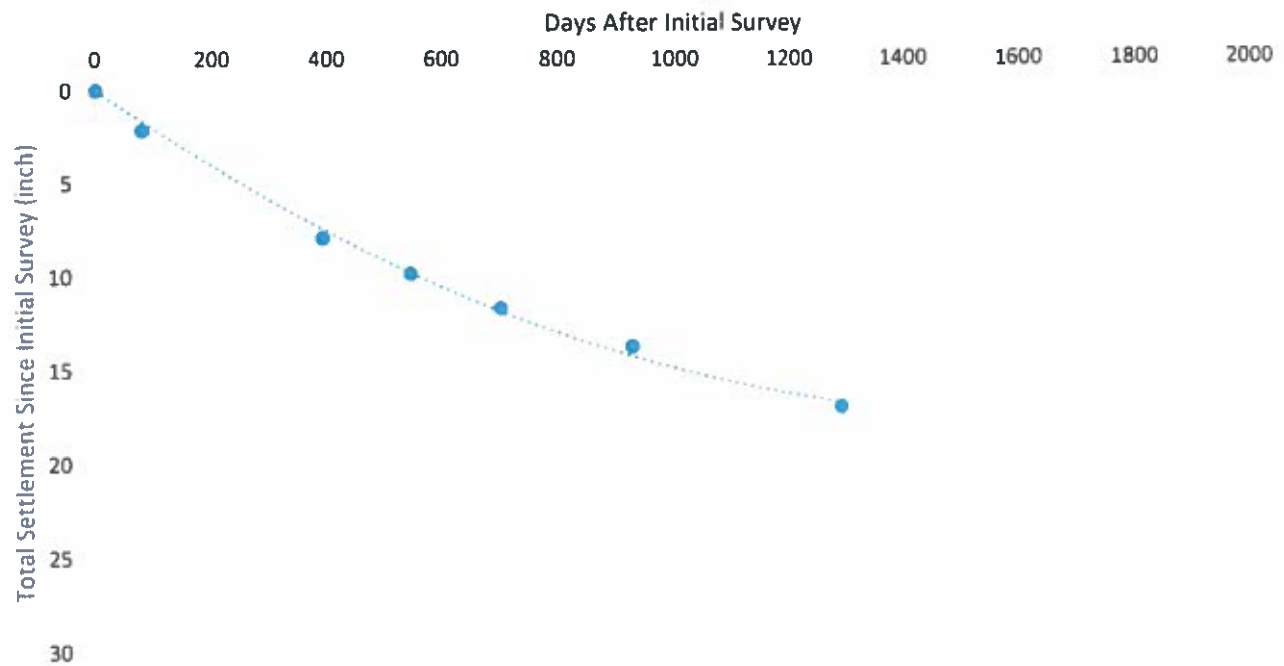
403-CP6					
Survey Date	Measured Elevations (feet)	Incremental Settlement Since Previous Survey (inch)	Total Settlement Since Initial Survey (inch)	Days After Previous Survey	Days After Initial Survey
7/2/2012	12.39	0	0	0	0
9/19/2012	12.21	2.16	2.16	79	79
7/29/2013	11.731	5.748	7.908	313	392
12/29/2013	11.5732	1.8936	9.8016	153	545
6/4/2014	11.4189	1.8516	11.6532	157	702
1/14/2015	11.249	2.0388	13.692	224	926
4/1/2016	10.98	3.228	16.92	443	1290
